950352

Data and Methods for Estimating the Severity of Minor Impacts

Mark N. Bailey, Bing C. Wong, and Jonathan M. Lawrence
MacInnis Engineering Associates Ltd.

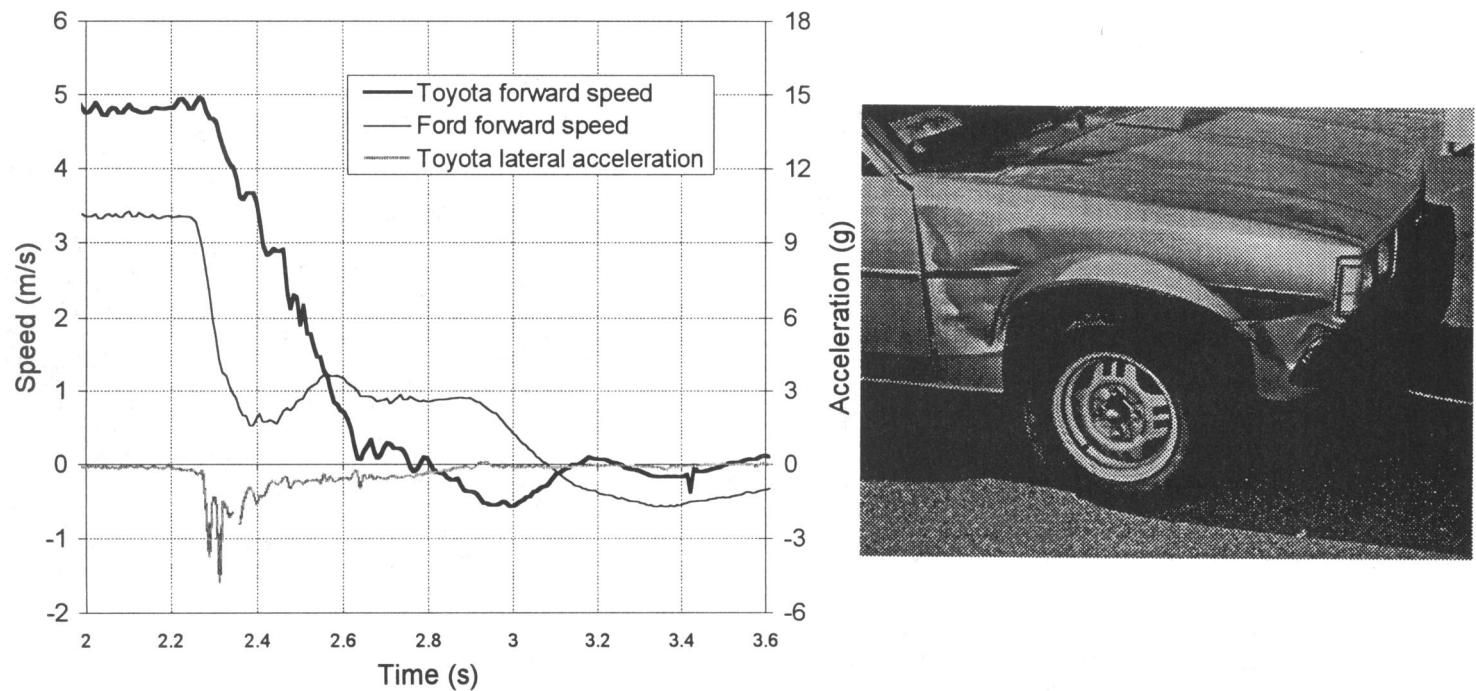
Figure 19. Speed and acceleration for test 1. Damage to right fender.

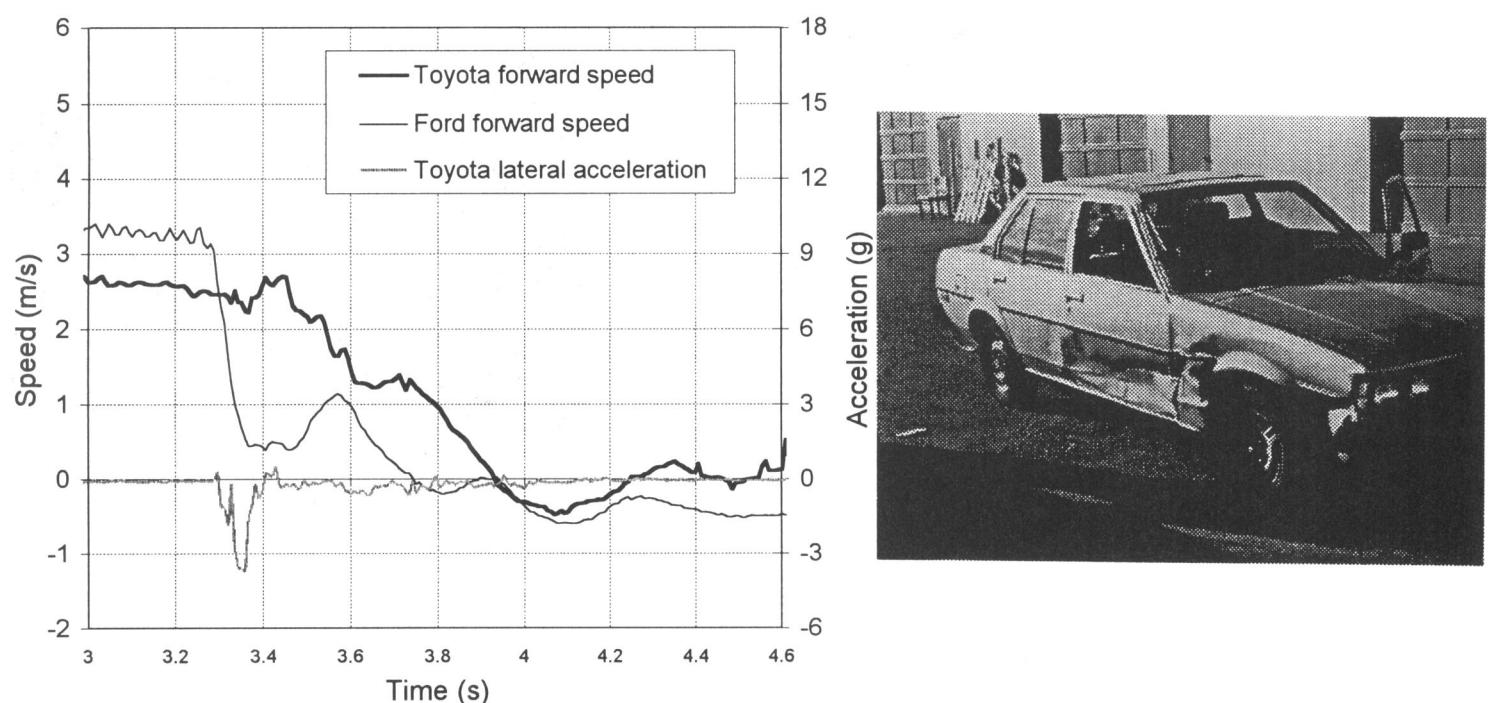
In Test 2 there was a 95 cm long contact mark on the right front door that reached a maximum depth of 9 cm. The right front window was rolled down prior to the impact, and shattered as a result of the impact. Even though the window was down, glass fragments were found inside and outside the vehicle. The impact changed the Toyota's heading by 10° clockwise. This rotation was the opposite direction from the previous test because the impact force was directed aft of the Toyota centre of mass. Figure 20 shows the Ford initial speed was approximately 11.5 km/h and its ΔV was approximately 7.2 km/h. The Toyota was initially moving forward at approximately 9 km/h and slowed to zero in about 800 ms, an average deceleration of about 0.32g. The Toyota lateral acceleration peaked at about 4g. The lateral ΔV was estimated to be approximately 6.2 km/h using equations 10 to 13. The total change in kinetic energy was approximately 3895 Joules.

Figure 20. Speed and acceleration for test 2. New damage to right front door. Old damage to right fender from test 1.

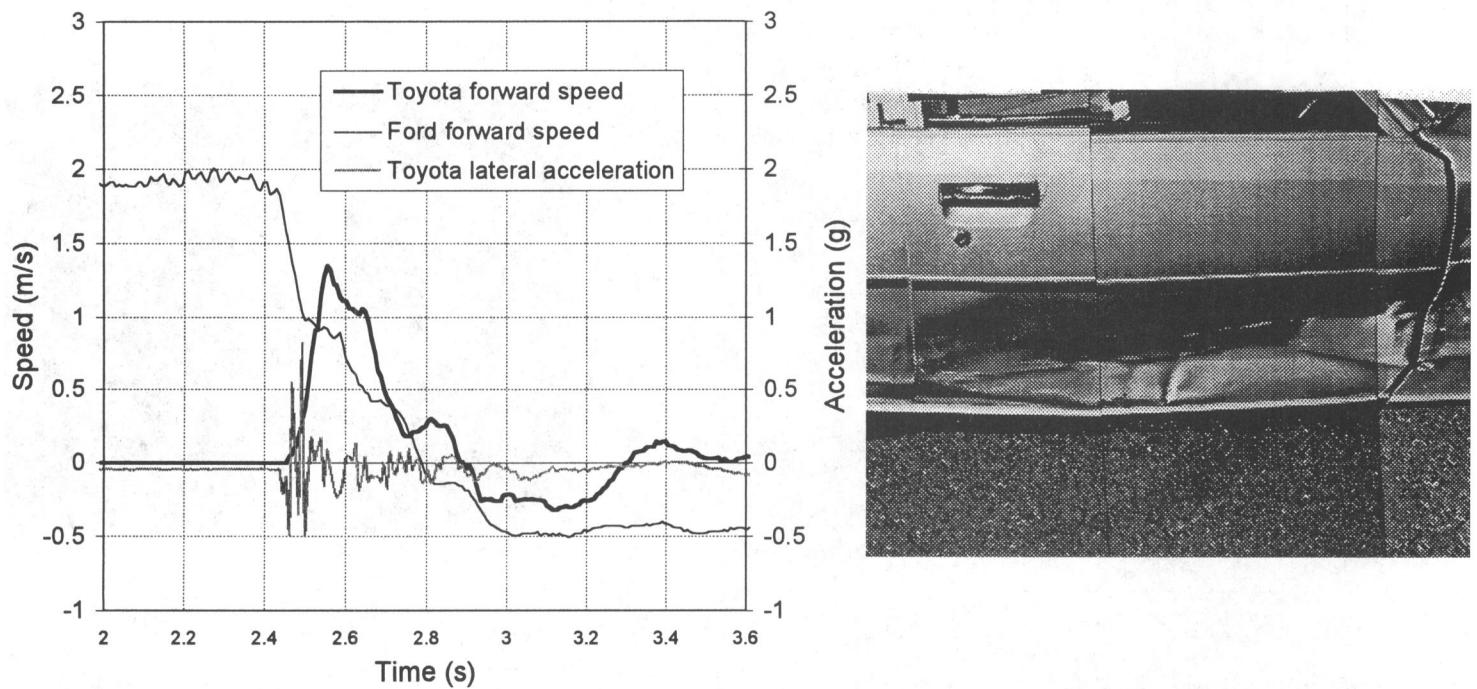
Figure 21. Speed and acceleration for test 3. Additional damage to lower right front door. Same area was damaged in test 2.

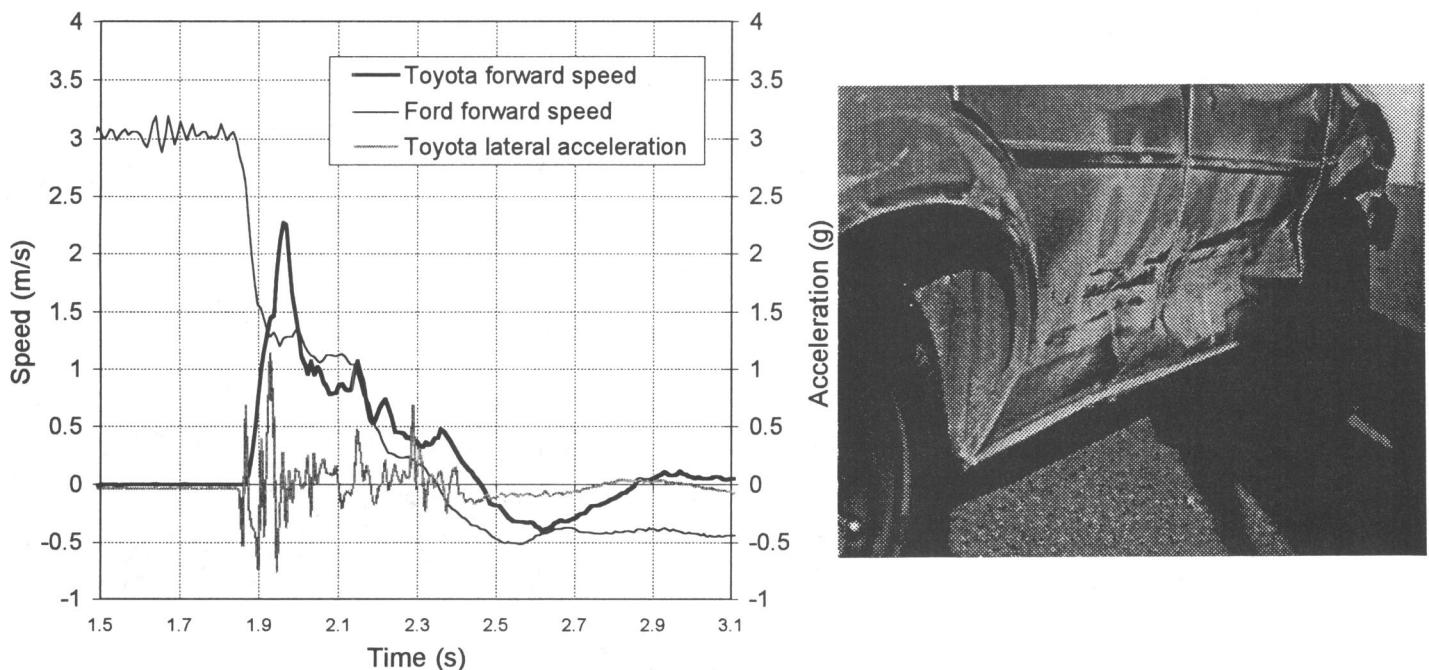
Figure 22. Speed and acceleration for test 4. Damage right rear door and B-pillar.

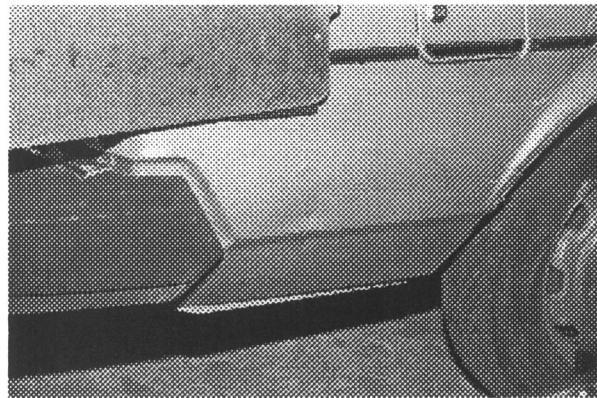
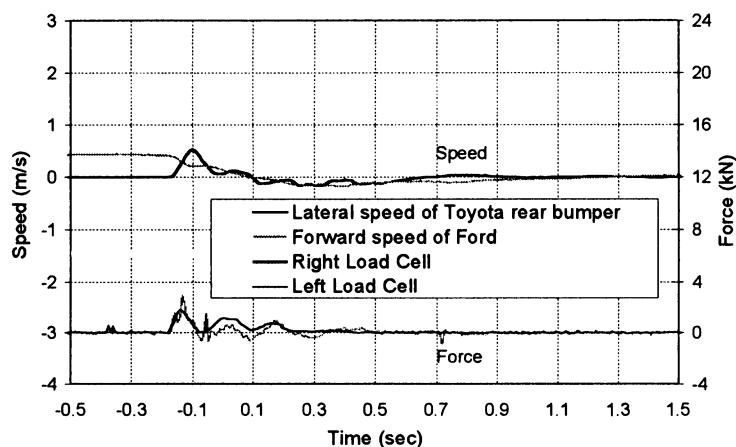
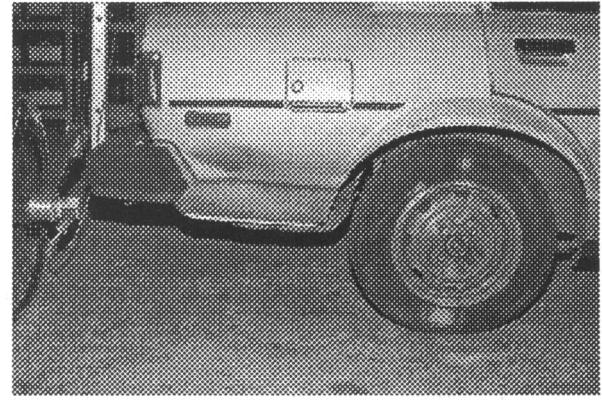
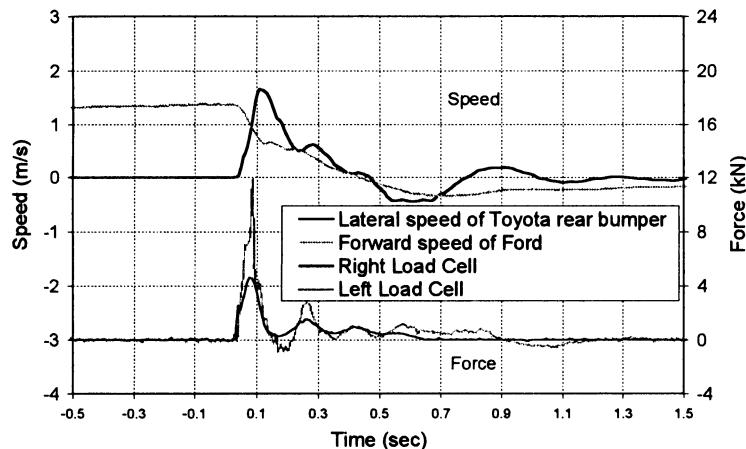
Figure 24. Speed and force data, test 18. Damage shown at right

In Test 18 the top of the left bumperette of the bullet Ford Escort hit the target Toyota Corolla right quarter panel aft of the rear wheel. There was no damage or isolator compression on the Ford, and a dimple in the quarter panel of the Toyota that was 50 mm in diameter and a maximum of 5 mm deep. Vertical scuffing on the 50 mm height of the damage indicated the Toyota had displaced vertically by approximately 50 mm at the contact point. In these tests, generally the bullet front bumper pitched downward slightly and the struck side of the target rolled upward. The wheels of the Toyota did not slide sideways as a result of the impact.

In Test 19 the engagement was identical to Test 18, but the closing speed was higher. The dent was at the same location on the target Toyota, only it was 200 mm in diameter and 18 mm deep at the centre and centred 301 cm from the front axle. There was also a small scrape on the rear of the right rear wheel arch of the Toyota from the bumper of the Ford. Neither of the Ford isolators compressed. The rear bumper of the target vehicle displaced sideways 19 cm relative to the ground. Figure 25 shows that the closing speed of the bullet Ford was approximately 1.4 m/s. After the first 100 ms the force between the vehicles dropped to zero. Unlike the previous test, the target vehicle slid sideways, so the bullet rolled ahead until it contacted it a second time and decelerated with it, but with very little force between the vehicles. Eventually the bullet vehicle disengaged and rolled away backwards. The ΔV 's at the Ford and Toyota centres of mass were approximately 0.8 and 0.5 m/s and the change in kinetic energy pre- and post-impact was approximately 438 Joules. 321 Joules were accounted for by the sliding tires, and the remaining 116 Joules were associated with the damage to the Toyota. The roof-top acceleration had a 2.3g peak with a 12 ms pulse width above a background of lower peaks that lasted a total of 100 ms.

In Test 20 the alignment was similar to the two previous tests, but the closing speed was high enough to cause 2 and 13 mm compression on the left and right Ford isolators. The target Toyota rear bumper moved 45 cm sideways relative to the ground. The front axle did not move sideways. The portion of the right quarter panel that was hit in the previous test was hit again in this test, causing the dent to increase in size. The dent was centred 290 cm from the front axle (11 cm closer). There was some new damage ahead of the target Toyota right rear wheel arch that was 6 cm in height, 4 cm in length and approximately 1 cm in depth. Figure 26 shows that the dynamics were similar to the previous test. The impact lasted approximately 100 ms, then the force between the vehicles dropped to near zero and then the vehicles decelerated in unison. The peak force at the bumper of the bullet was approximately 25 kN for an average isolator compression of 7.5 mm (front-end vehicle-to-barrier impact: peak force=24 kN, isolator compression=7.5 mm). The change in kinetic energy pre- and post-impact was approximately 1092 Joules. 569 Joules were associated with isolator compression and work done by the sliding tires, and 523 were associated with the Toyota damage. The top accelerometer measured a 3.5g peak with pulse duration of 10 ms above a background of lower peaks.

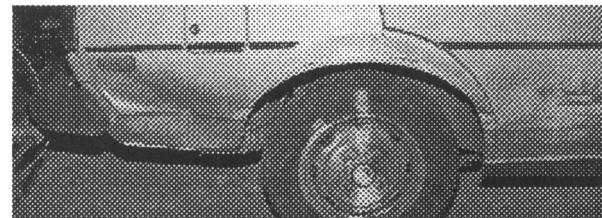
Small dimple in quarter panel from Ford bumperette.

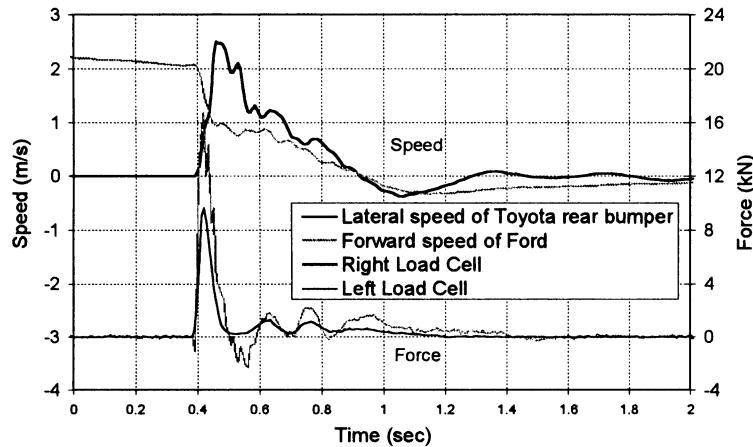
Dent in quarter panel, 200 mm diameter, 18 mm maximum depth.

Figure 25. Speed and force data, test 19. Damage shown at right.

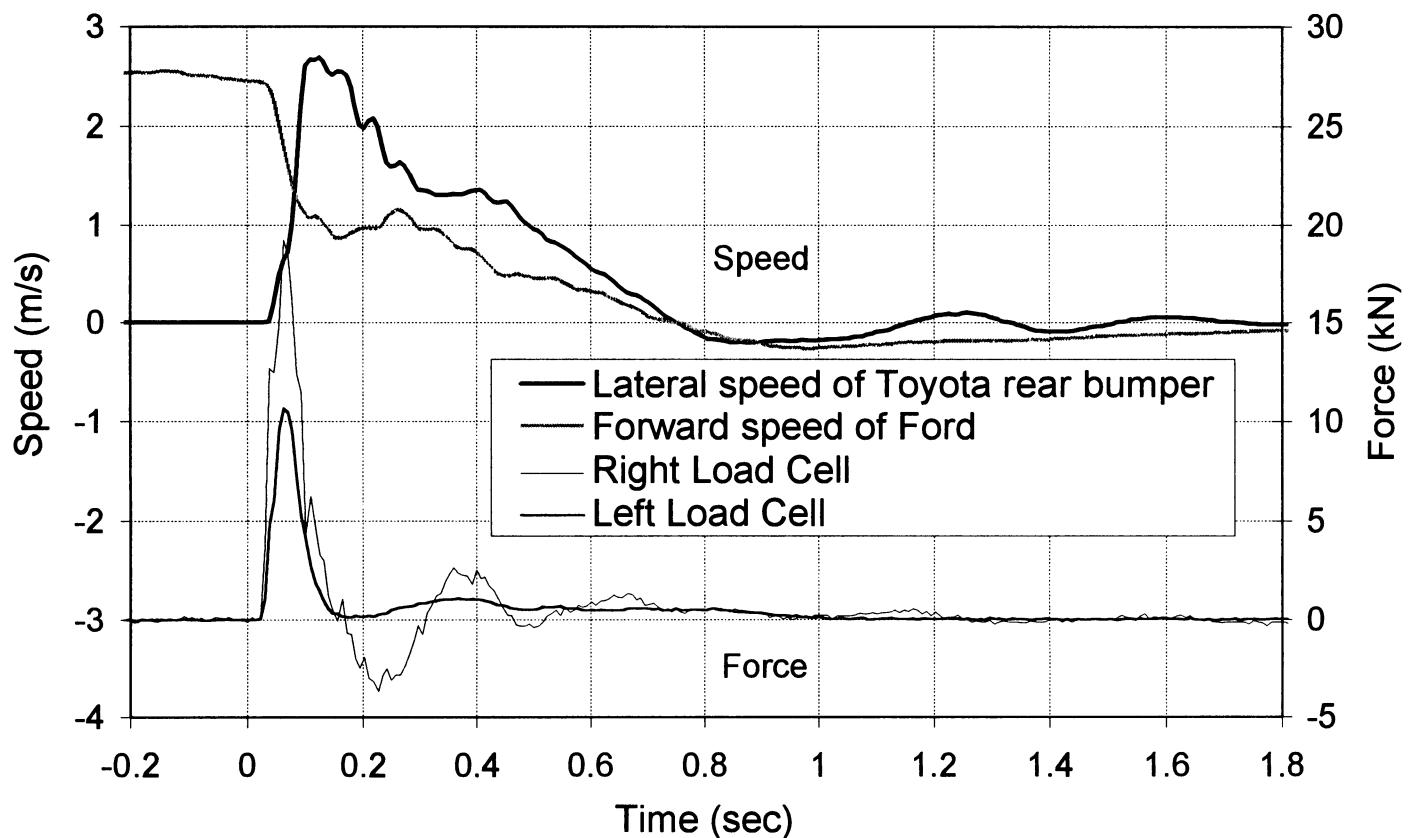
Figure 27 (a). Speed and force data for test 21.

In Test 21 the alignment was similar to the three previous tests, but the bullet Ford was slightly more forward. The impact speed was 8.6 km/h. On the Toyota there was a 16 cm long dent in the rear door approximately 20 mm deep. There was a black scuff in the dent that went forward and downward. It was caused by the motion of the Toyota relative to the Ford, which was upward and backward. The dent in the Toyota right rear wheel arch had doubled in depth to 2 cm. There was 7 and 20 mm compression on the left and right Ford isolators. The target Toyota rear bumper moved 79 cm sideways relative to the ground and the front axle did not move. Figure 27 (a) shows that the dynamics are again similar to the previous tests. The change in kinetic energy pre- and post-impact was approximately 1638 Joules. The energy absorption associated with the 13.5 mm average compression is 460 Joules. 733 Joules were associated with the Toyota damage. The top accelerometer measured a 4g peak with a 110 ms pulse width (Figure 27 (b)).

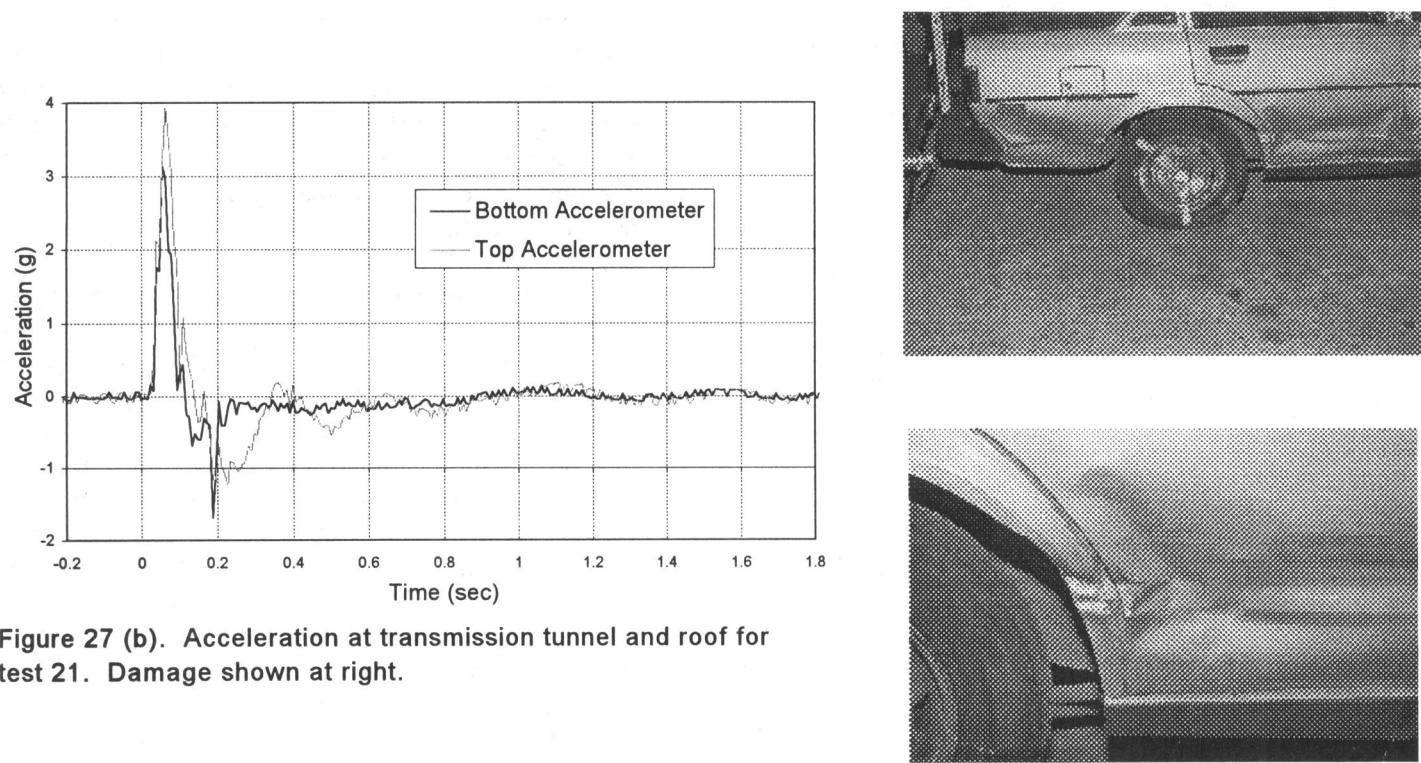
Figure 27 (b). Acceleration at transmission tunnel and roof for test 21. Damage shown at right.

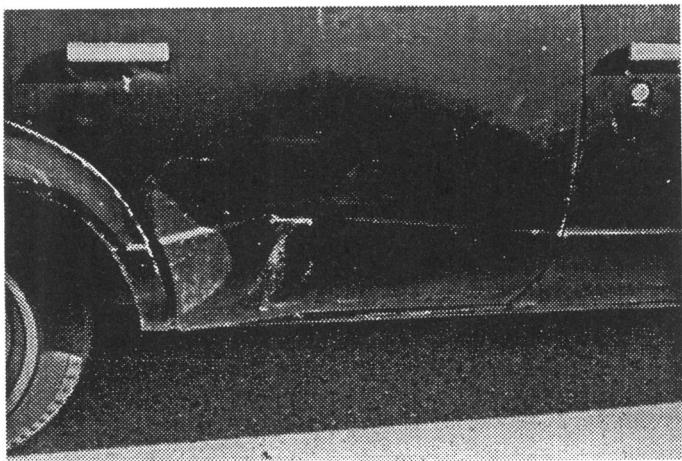
Figure 29. Chevrolet Malibu lateral impact. Energy absorption by door was approximately 400 Joules. Dent is 64 mm deep.

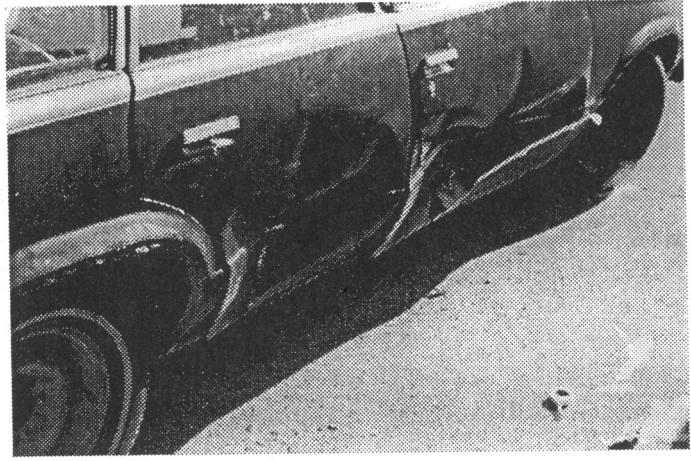
Figure 30. Chevrolet Malibu lateral impact. Energy absorption by door was approximately 900 Joules (forward door). Dent is 102 mm deep.

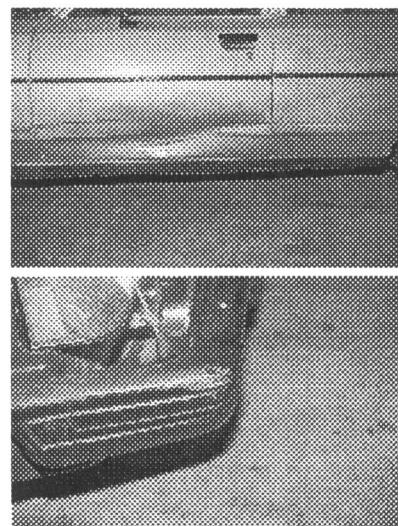
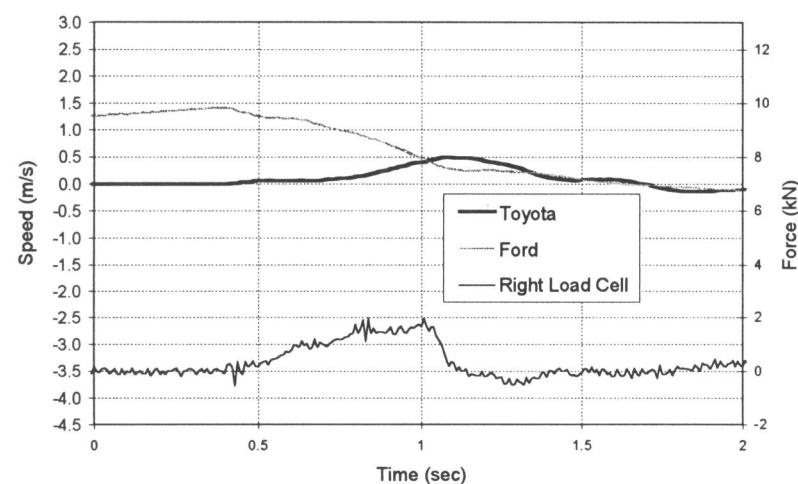
Figure 33. Speed and force for test 23. Damage at right.

For test 23, the Corolla was oriented at an angle of 16° to the path of the Escort and positioned so that the right corner of the Escort's front bumper would contact its left front door. Velocity, force and damage are shown in Figure 33. The impact produced a black scrape mark running from the back of the Corolla's left front door to a point 45 cm behind the leading edge of the door. The scrape mark was associated with a dent in the door skin that had a maximum depth of 40 mm. Again, the scrape mark ended lower than it began, by about 4 cm. During the impact, both vehicles came to rest and then moved backwards. The Corolla came to rest behind its original position. The vehicles were not in contact when they came to rest. The left and right load cells both recorded compressive loads for the initial phase of the impact. After the vehicles were engaged, the right load cell recorded a tensile load which correspond to a slowing of the target vehicle. The right load cell peaked at approximately 1600 N.

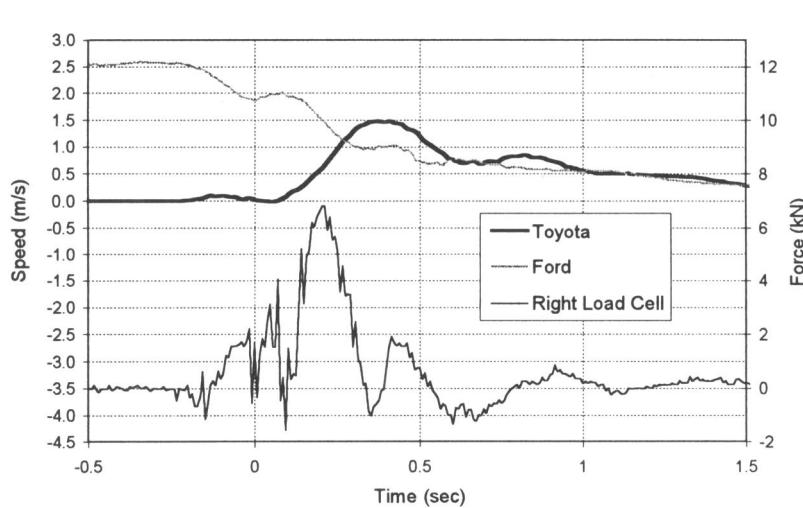
Figure 34. Speed and force for test 24. Damage at right.

For test 24, the Corolla was oriented at an angle of 16° to the path of the Escort and positioned so that the right corner of the Escort's front bumper would contact its left front door. Velocity, force and damage are shown in Figure 34. The impact produced a black scrape mark on the middle of the Corolla's left front door and fender. Denting of the door skin was not significantly increased over that due to previous impacts. The right corner of the Escort bumper became lodged behind the left front wheel of the Corolla, and the two vehicles came to rest in contact.

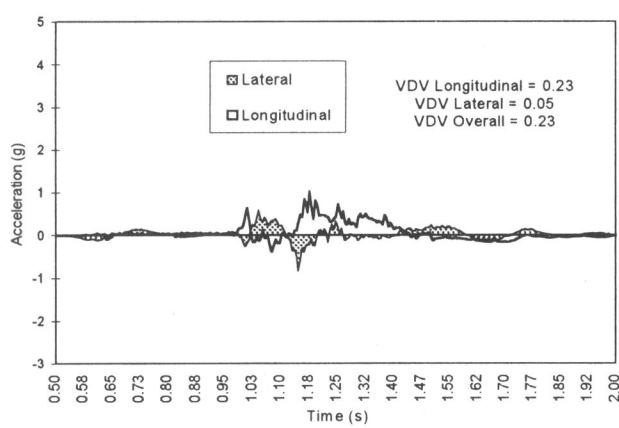
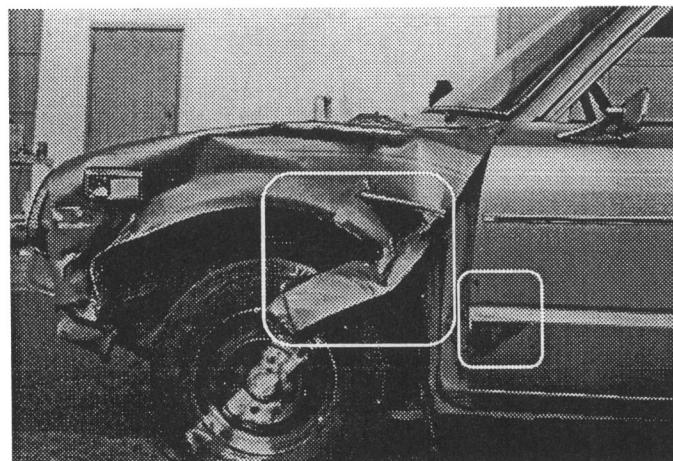
Figure 38. Acceleration for test SS12. Damage at right.

SS12	38	Right corner of the Dodge struck the left door of the Honda just in front of the B-pillar. Damage to the Honda consisted of horizontal scrape marks down the length of the left door. The Dodge came to rest in contact with the Honda as a result of the impact.	1.0	300	0.8	100	1000
SS13	39	Initial contact behind the B-pillar and more pronounced denting of the door skin as well as a dent in the left quarter panel. The Dodge came to rest as a result of the impact, in contact with the Honda. The damage was similar to the previous test.	1.4	30	0.5	150	1400
SS17	40	Initial contact occurred with the left corner of the Dodge front bumper striking the right door of the Honda, about 30 cm behind the front of the door. As the front bumper of the Dodge moved forward it caught the rear edge of the right fender. The damage was similar to test SS11. The Dodge was not brought to rest by the impact.	3.0	40	3.0	40	1300

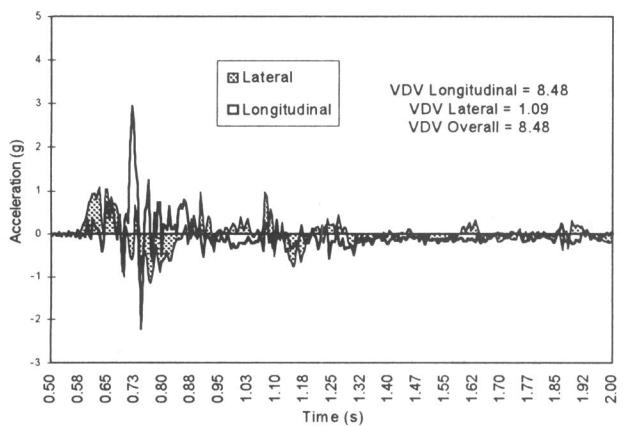
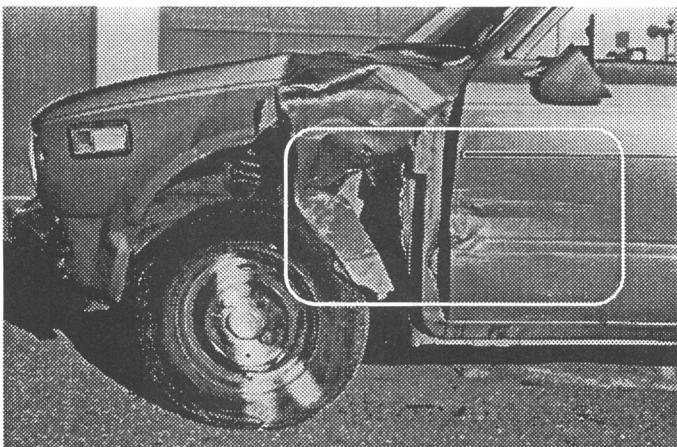
Figure 41. Acceleration for test SS18. Damage at right*.

SS18	41	The left corner of the Dodge front bumper struck the right door of the Honda behind the mid-length of the door, similar to tests SS12 and SS13. The door skin was dented, and the fender damage caused by test SS17 was added to. The Dodge was not brought to rest by the impact. A mark on the door ended lower than it began, owing to body roll, as in other side swipe tests. In contrast to tests SS12 and SS13, the longitudinal acceleration did not surpass 1g until the lateral acceleration did. The 3g peak likely occurred at the door leading edge where the door skin was deformed around the stiff frame of the door leading edge.	3.0	50	2.0	30	1400
SS19	42	The Honda was oriented at a larger angle to the longitudinal axis of the Dodge. Initial contact occurred between the left corner of the Dodge front bumper and the back of the Honda right door. Denting of the door skin was increased due to bumper contact as well as from contact with the Dodge fender, resulting in a scrape and dent above the trim line on the Honda door. The Dodge was brought to rest by the collision and the two vehicles remained in contact. There were lateral accelerations of larger duration and amplitude than the other tests due to the increased angle.	2.5	40	2.5	120	1400

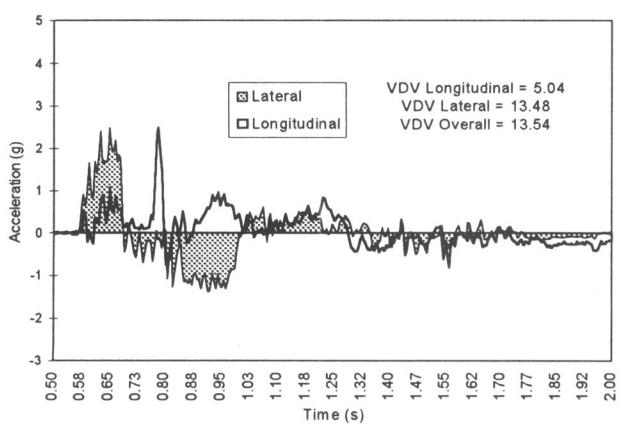
Figure 42. Acceleration for test SS19. Damage at right*.

* Damage is to right side. Image mirrored for comparison to previous figures.
